QUALITY ADVANTAGE BLOWER MOTORS

BLOWER MOTORS

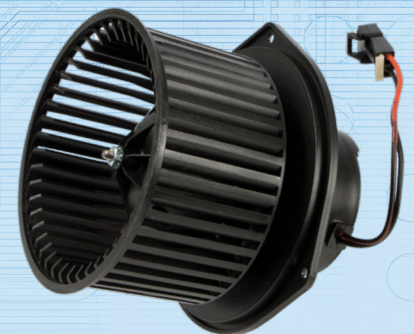
Four Seasons® P/N 75777 & 75778 Unit

Four Seasons® provides a hassle free, drop-in-replacement design that does not require any kind of special installation kit. With the installer in mind, we designed a motor that would not only fit and perform as needed, but would also be easier to install, saving both time and money.
